### The Problem

### The Solution

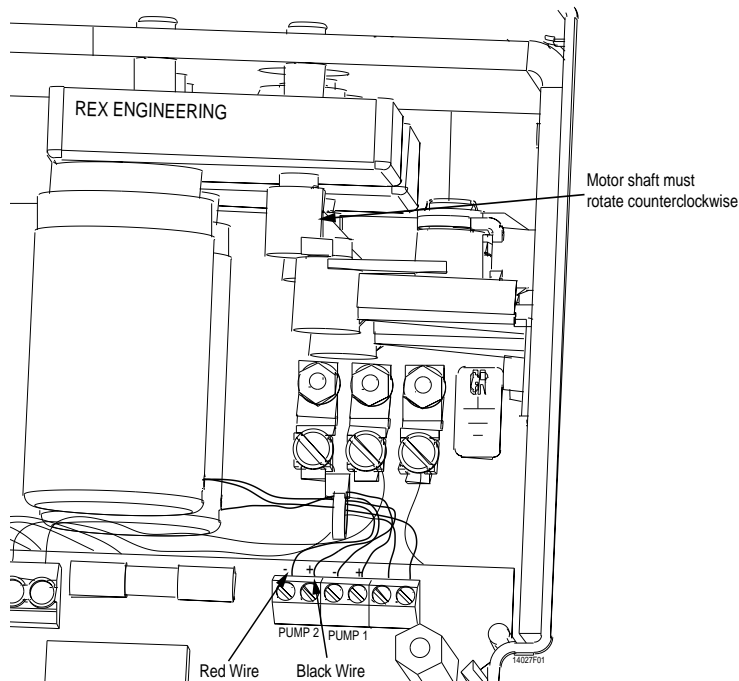
Certain BioCal products manufactured after June 20, 2000 have been found to have pump motors operating in reverse. This can result in the linkage between the gearbox output shaft and the pump piston binding, causing the linkage to become disconnected.

Figure 1. Cutaway drawing showing Pump 1 and Pump 2 wires and terminals.

3. Find the terminal block that says PUMP 1. Disconnect the red wire from the positive (+) terminal and the black wire from the negative (-)
4. Reconnect the black wire to the positive (+) terminal, and the red to the negative (-) terminal as shown in Figure 1.

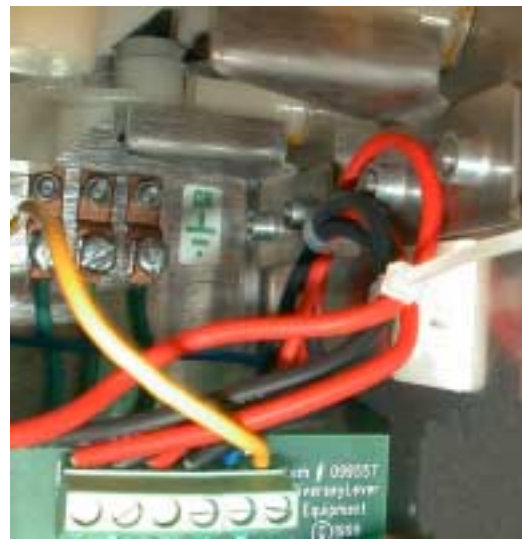
Also included with this repair packet is a wire harness that you will install to ensure wires do not get caught on crank shaft.

Figure 2. Pump terminal wires secured with wire harness and tie wrap.

5. Repeat these steps for the PUMP 2. terminal block.
6. Attach wire harness with tie wrap to right wall of BioCal, and secure black and red wires into it as shown in Figure 2. Make sure that wire harness is far enough from pump linkage so that it doesn't catch on crank shaft.
