# Equipment Technical Bulletin

## Motor Gearbox Replacement

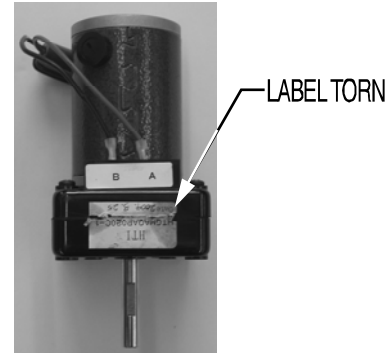
Vendor left a spacer out of some gearboxes assemblies in a small lot of the assemblies. These need to be replaced with new motor gearboxes or excessive wear and premature failure could result.

The absence of the spacer has resulted in torn labels as shown in the pictures.

*Motor Gearbox with Torn Label*

1. Install new motors sent with this technical bulletin.
2. Discard old motors.

1. Disconnect power to the pump box.
2. Remove the front pump plate.
3. Remove the screws securing the pump panel and gently pull out on the bottom of the panel. When the alignment pins are free of the chassis, the panel will drop down.
4. Remove motor wires from gearbox (note color codes).
5. Remove pump tube.
6. Unscrew four screws from rear pump housing.
7. Remove motor/gearbox assembly through top of cabinet.
8. Install new motor by reversing the above steps (take care to replace motor wires by color-coded locations).

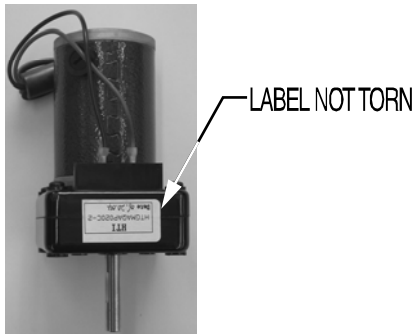
*Motor Gearbox with Label Intact*
