Equipment Technical Bulletin

ILS Controller Module Short

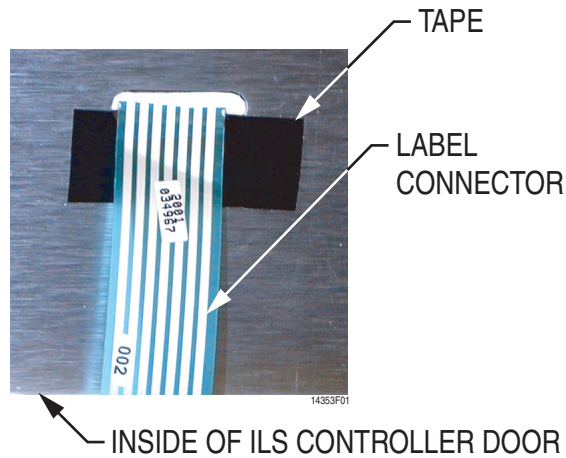
This bulletin applies to item number 087279, controller module for ILS. We have received reports of product failure due to a short created between the conductors in the mylar label connector and the stainless steel door, ultimately requiring the label to be replaced.

Since July 10, 2000, Beta has solved this problem by building the ILS with a barrier between the mylar cable for the label switches and the edges of the hole in the stainless steel control module door. However, if you purchased your ILS before July 10, 2000 it might not have this solution in place. If this is the case, simply place a piece of electrical tape over the edge of the hole in the ILS controller module (087279) door to provide a barrier between the mylar cable and the stainless steel.
