# Equipment Technical Bulletin

## ILS/ILS Max/ILS MaxT: Dosing Error with High Viscosity Chemicals

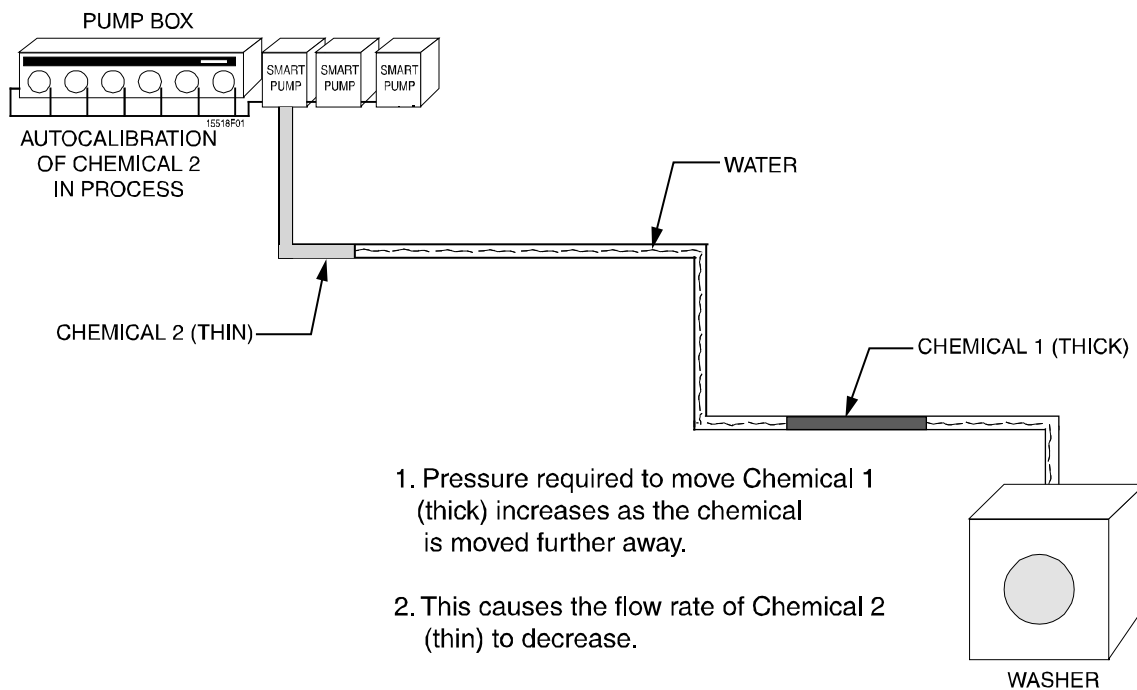
If the ILS, ILS Max or ILS MaxT is programmed to deliver a thick and then a thin chemical, one after another to the same washer (through the same transport pump), the automatic calibration feature may misinterpret the chemical flow and record an incorrect calibration. The dispenser may then use this erroneous calibration to feed the next few calls for chemical. This incorrect dose amount could be delivered to the washer that called for the two chemicals, or to another washer that calls only a single chemical soon thereafter.

1. Pressure required to move Chemical 1 (thick) increases as the chemical is moved further away.
2. This causes the flow rate of Chemical 2 (thin) to decrease.
3. Calibration errors in both Chemical 1 and Chemical 2 may result.

- Rearrange the chemical order so that thin chemicals are followed by thick chemicals.
- Set pump to a lower speed when pumping thick chemical so that it is thinned with more water.
- Flush with warm or hot water to dissolve and thin viscous chemicals for transportation.
- Use larger-diameter transport tube. For ILS Max, we recommend 1/2"ID delivery tube for normal installations. Using 5/8"ID tube will reduce the load on the transport pump. For ILS and ILS MaxT, we recommend 3/8"ID delivery tube for normal installations. Using 1/2"ID tube will reduce the load on the transport pump.
- Bring the dispenser closer to the washer to decrease transport distance.
- If you have sufficient triggering flexibility, delay the beginning of the dose of the second (and all subsequent) chemical until the first chemical has been delivered to the washer.
