Equipment Technical Bulletin

Pump Motor Failure Update

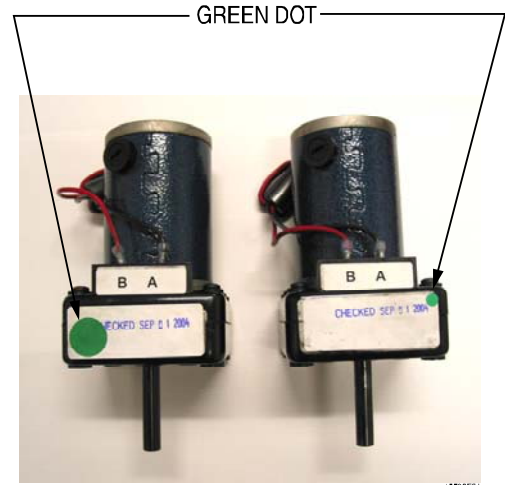
Replacement Motor Gearbox

Replacement motor gearboxes can be identified by the **green** (NOT orange) dot and check-date notation as shown to the right. Dates on motors should be August 28, 2004 or later. Replacement motor gearboxes are also marked with "SC-1" for 98 RPM motors or "SC-2" for 200 RPM motors.
