Equipment Technical Bulletin

L5000Plus/XL: Manifold QF Cable Harness Issue

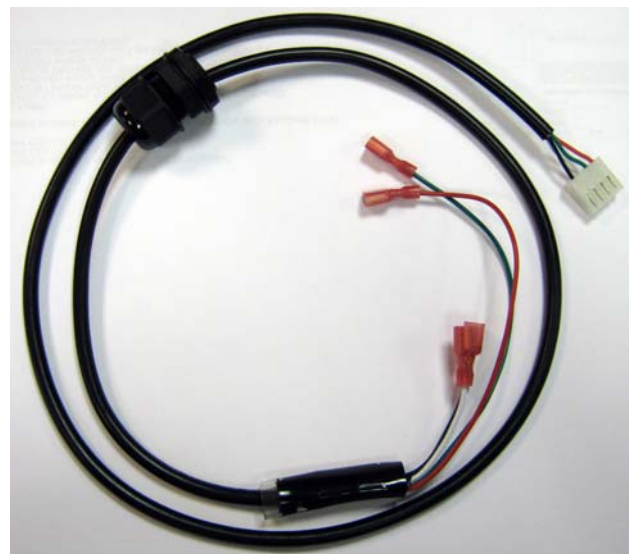
Manifold QF Cable Harness

We have received reports recently of failures of the Manifold QF cable harness. An investigation has found that a small number of harnesses contained defective electronic components. On installation these can give any of the two symptoms described below:

If these symptoms occur, contact Customer Service to replace the harness. The items listed below that have a date code before 8/19/2009 are affected:

For these items, replace the cable with harness code #1207428:

For these items, replace with harness code #1207437:
