Installation Instruction

100 Series Pump Motor Life Issue

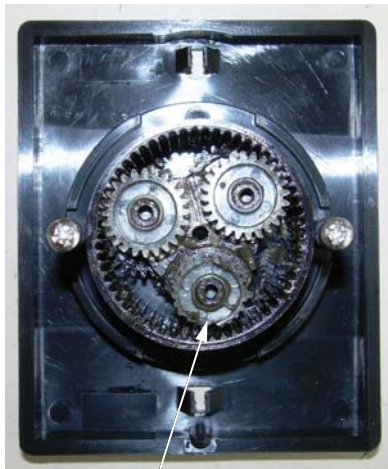
Some units with 100 Series Pump motor gearboxes shipped from Santa Cruz from November 17, 2006 to December 12, 2006 may have decreased motor gearbox life. The symptom of decreased life is that the motor becomes very loud, and eventually stops working due to premature gear wear, such that gear teeth wear out more quickly than usual, as shown on the bottom gear in the picture.

WORN GEAR
TEETH

The main root cause of this problem was temperature during the gear production process. This lot had gears produced on a different mold machine which will not be used again.

We plan on shipping replacement motor gearboxes to customers who received suspect motor gearboxes. If you are receiving this notice with a shipment of motor gearboxes, please replace motor gearboxes on units we shipped to you during the period of November 17, 2006 to December 12, 2006.

Please note that as a continuous improvement measure we have also begun adding a plastic plate on top of the gears, which has been shown in lab tests to substantially improve motor/gearbox life well beyond our target of 1000 hours run time (at 10 psi).
