Equipment Technical Bulletin

Premature Motor Failure in ILS, ILS Max, ILS MaxT
Summit XL and P-6100T Big Wheel Pumps

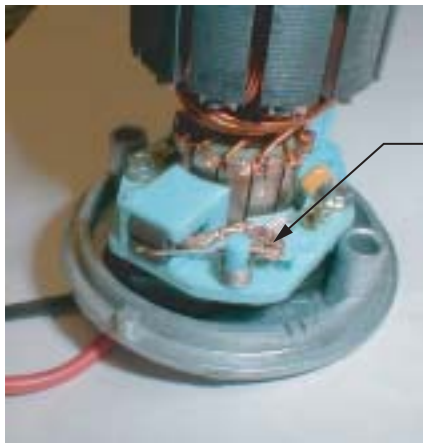
15062F01

We have received reports from the field of premature pump motor failure in Big Wheel pumps. The symptom is a motor that stops operating entirely or stops working but can be restarted by striking the motor housing. The problem stems from brush lead wires on some motors; our motor supplier coiled them too tightly. This tight coiling prevents the brush from moving in the brush holder as the brush wears. See photographs below.

Due to the high level of disassembly required, field repair of the motor/brush assembly is not practical. Beta will replace any motor/gearbox assemblies, free of charge, for pumps exhibiting the symptoms described above. Please contact your Customer Service department to order replacements.
