Equipment Technical Bulletin

Summit OPL Flush Mandatory Firmware Upgrade

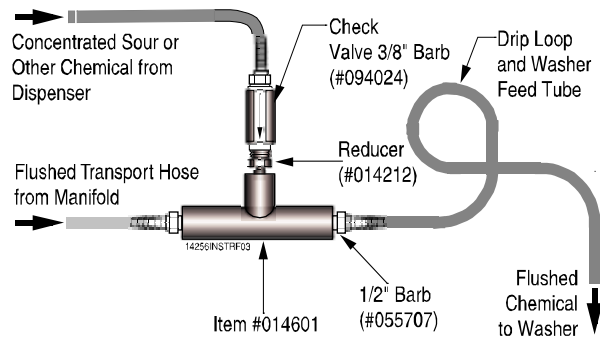
Pumping incompatible chemicals: Per the dispenser manual, incompatible chemicals must not both be pumped into the manifold. If you are pumping both alkali and peroxide or chlorine bleach and sour into the manifold, you need to separate one of them out to be injected downstream from the flush manifold by using a sour flush kit 069505.
