Equipment Technical Bulletin

Summit OPL and XL Flush Manifold Reliability Upgrade

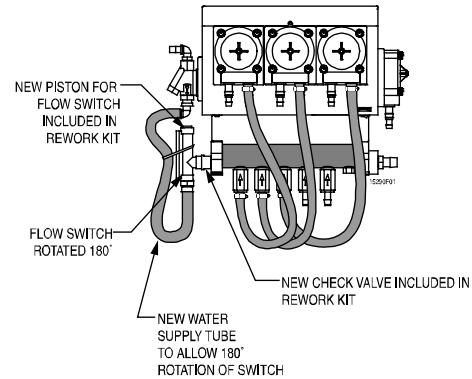
Summit OPL with Flush Manifold and Parts Included in Upgrade Kit

- An upgrade kit consisting of an improved check valve and looser-tolerance flow switch.

Our lab tests showed an improved resistance to debris in the water supply if the flow switch is rotated 180 degrees. The Installation Instructions with the upgrade kit explain how to do this.

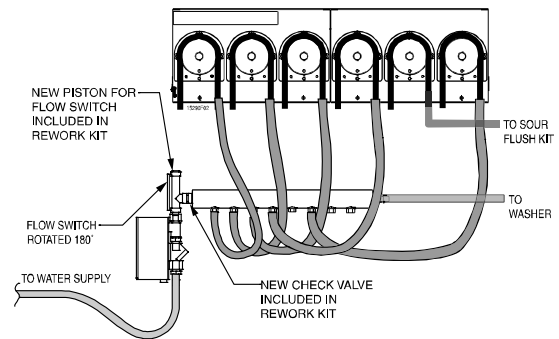
Summit XL with Flush Manifold and Parts Included in Upgrade Kit
