PROBLEM

Summit XL units with firmware V1.3 or lower can pump chemical into the manifold without flush if:

This ETB applies only Summit XL; it does not apply to white programmer versions of Summit OPL.

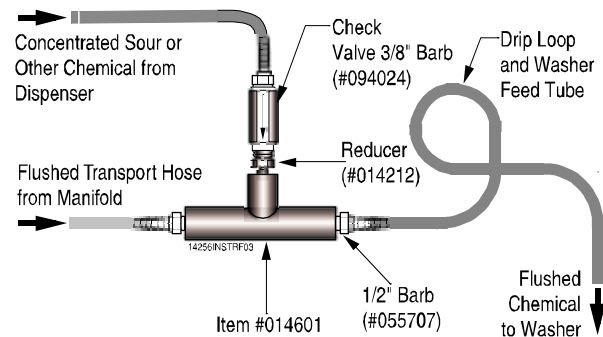
Pumping incompatible chemicals: Per the dispenser manual, incompatible chemicals must not both be pumped into the manifold. If you are pumping both alkali and peroxide or chlorine bleach and sour into the manifold,

you need to separate one of them out to be injected downstream from the flush manifold by using a sour flush kit 069505.
